EARTHQUAKE PERFORMANCE OF AUSTRIAN DAM, CALIFORNIA DURING THE LOMA PRIETA EARTHQUAKE

By John Vrymoed¹, Wallace Lam²

Abstract

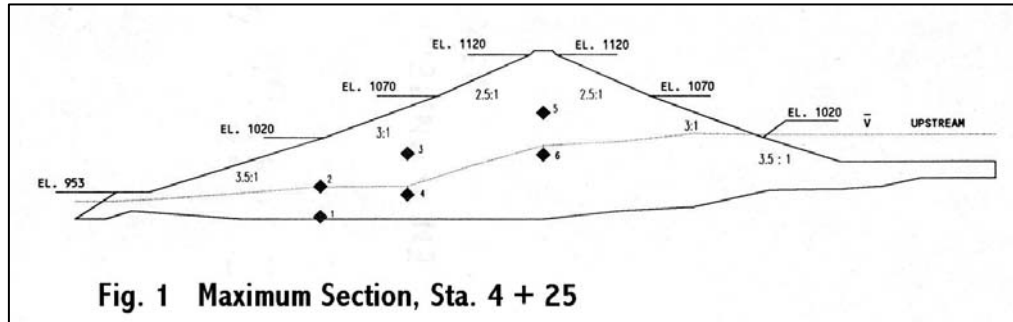
Fig. 1 Maximum Section, Sta. 4 + 25

piezometers are shown in Figure 1.

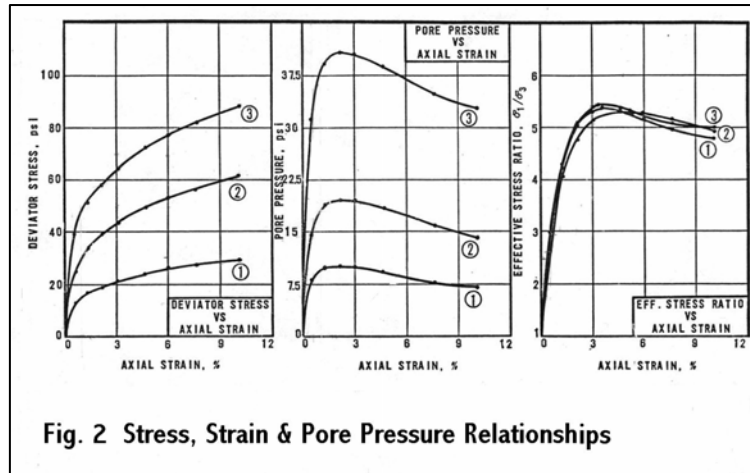
Fig. 2 Stress, Strain & Pore Pressure Relationships

Isotropically consolidated undrained triaxial (ICUE) tests with pore pressure measurements were carried out on six 5.75-inch diameter undisturbed samples taken from both the up and downstream zones. Results for three tests are shown in Figure 2. Test results showed no significant difference in strength characteristics between the material from the up and downstream zones. Combining all test results, average effective strength values of 44 degrees friction and zero cohesion and total strength values of 21 degrees friction and 290 lbs/ft² cohesion were determined. The foregoing properties were determined by Wahler Associates in a 1979 seismic stability investigation.

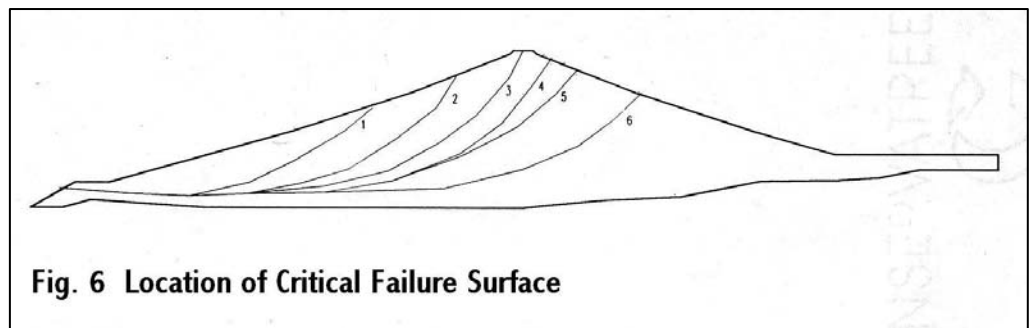
cross-section was analyzed to determine if a slope stability analysis could predict the location of longitudinal cracking. Six failure surfaces, shown in Figure 6, having the same coordinates near the toe, were varied throughout the downstream zone so that the slopes on either side of the crest were intersected at different locations. Results indicated that failure surface #4, intersecting upstream zone below the crest, was the most critical. This location coincides with the location of longitudinal cracking on the upstream slope. Hence, the earthquake induced cracking occurred at the location where mobilization of static stresses are predicted to be maximized.

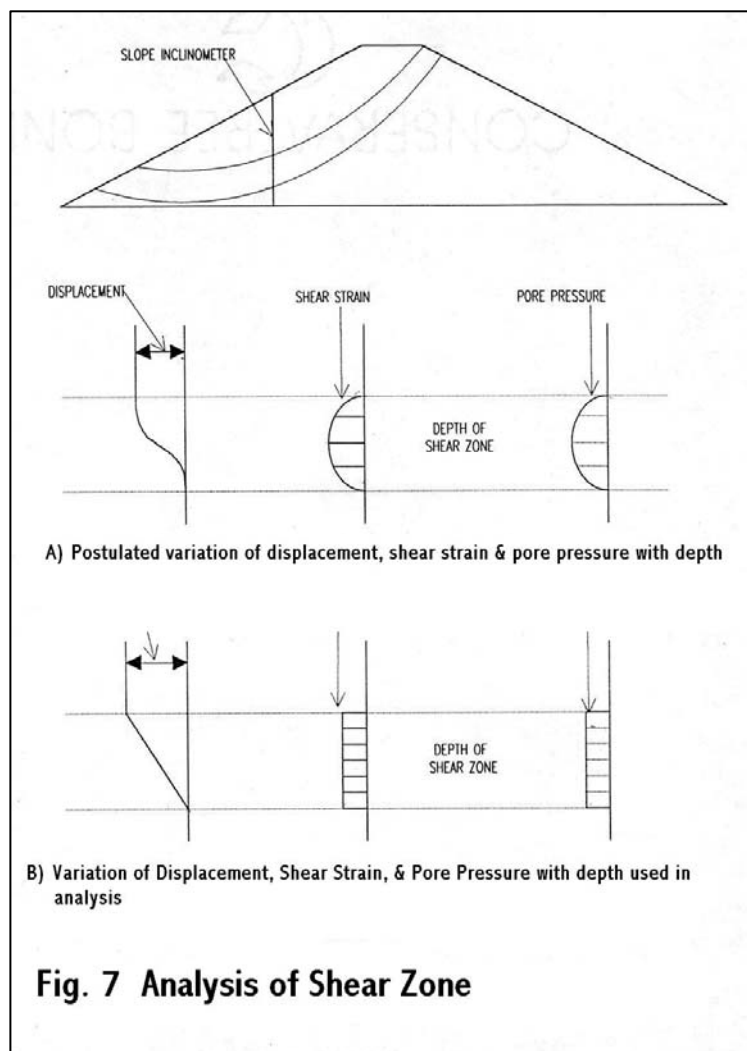
Fig. 7 Analysis of Shear Zone

Displacements are computed by analyzing the shear zone to determine its effect on the yield acceleration of the block above it. The analysis considers a plane strain condition where the soil is sheared over the thickness of the shear zone as illustrated in Figure 7.

Figure 7a shows the postulated variation of permanent displacement with depth as measured by a hypothetical slope inclinometer and the

corresponding shear strains and pore pressures. To simplify the analysis, a linear variation of displacement was assumed which results in constant average shear strains and pore pressures as shown in Figure 7b.

The FLAC predicted shear strains and displacements, shown in Figure 13, are similar to those postulated in the decoupled analysis, shown in Figure 7. FLAC predicts the extent of shearing to occur over a depth of 45 feet which is less than the 60 feet observed on the extent of longitudinal cracking on the slopes. It also predicts the extent of shearing, at depth, to increase during the earthquake time history. The resultant displacement of the downstream block is about 2 feet which is equal to the computed displacements at Sta. 4+25 as shown in Tables II and III.

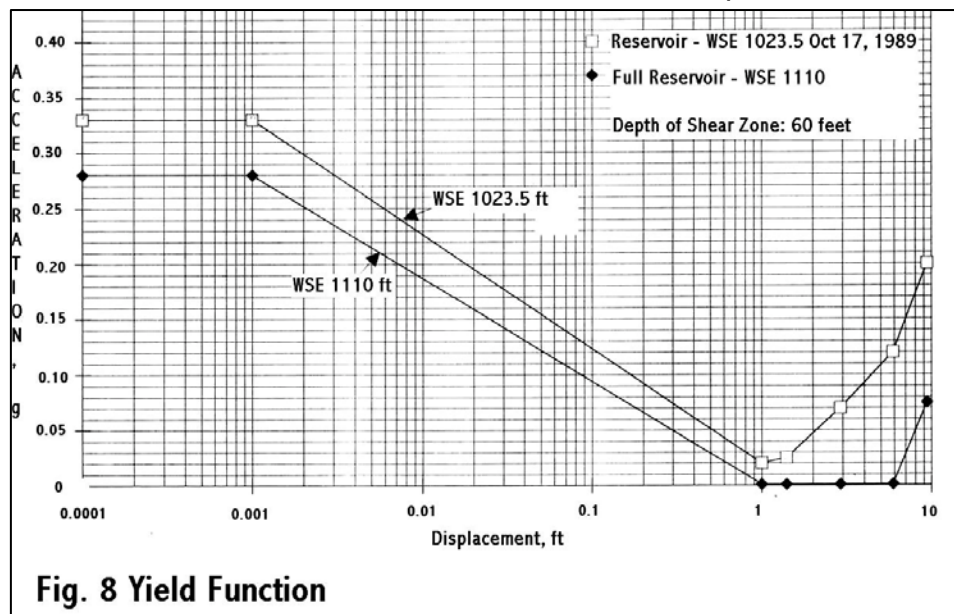
Fig. 8 Yield Function

referred to as a yield function and is established by determining the shear strength parameters by digitizing the applicable stress strain curves. Ideally, anisotropically consolidated strength data would be used. In this analysis, ICUE strength data were used to determine the yield function as these were the only data available. The resultant yield functions are shown in Figure 8 for a reservoir level existing at the time of the earthquake and a full reservoir.

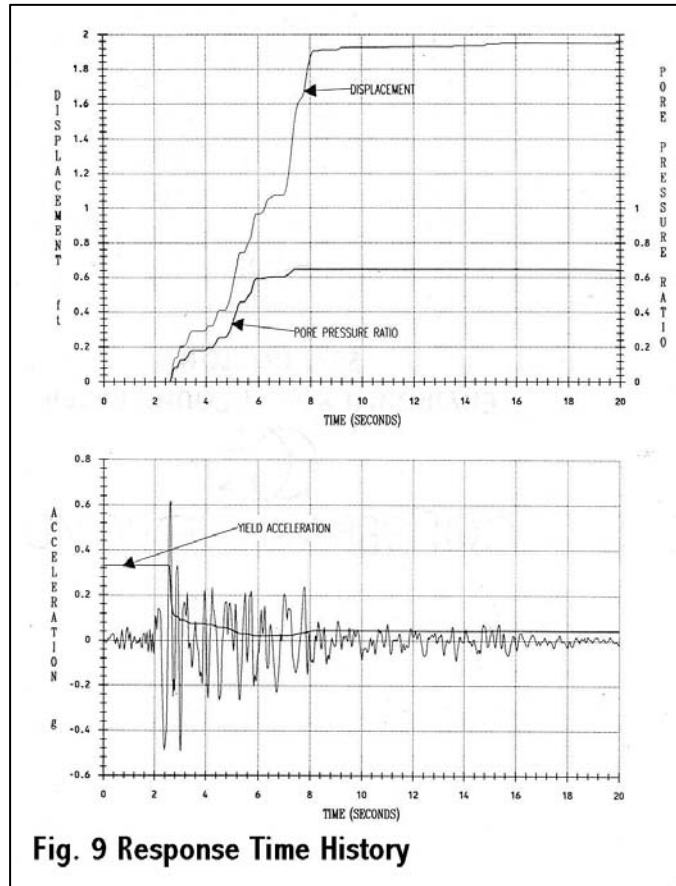
Fig. 9 Response Time History

The acceleration time history is shown in Figure 9 with the corresponding yield acceleration superimposed. Also shown are the computed displacements and pore water pressure ratios. The pore pressure ratio is the pressure normalized with the initial effective confining pressure from the ICUE tests. It represents the effect of undrained shearing on the average pore pressure within the shear zone. Yield functions were similarly calculated for Sta. 2+50 which is near the left abutment and displacements calculated. The resultant displacements are shown in Table II.
